2012–2017

EVERGLADES

Report Card

This is a RECOVER product that provides a transparent, timely, and geographically detailed assessment of health of the Florida Everglades using data from May 1, 2012–April 30, 2017.

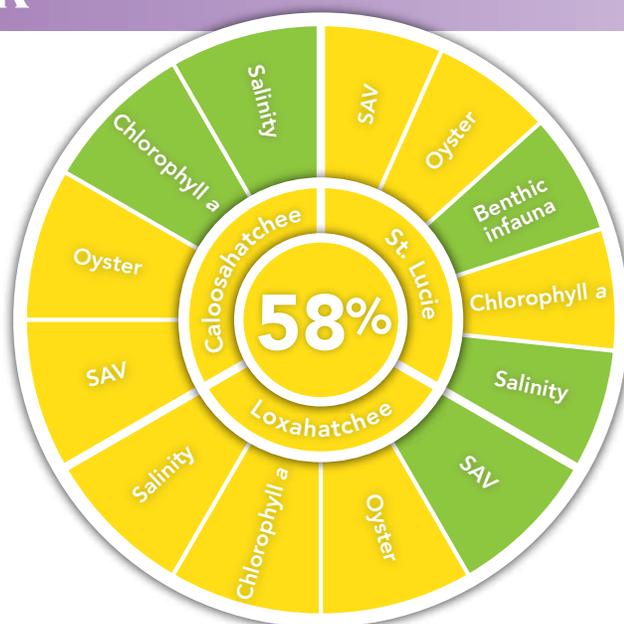
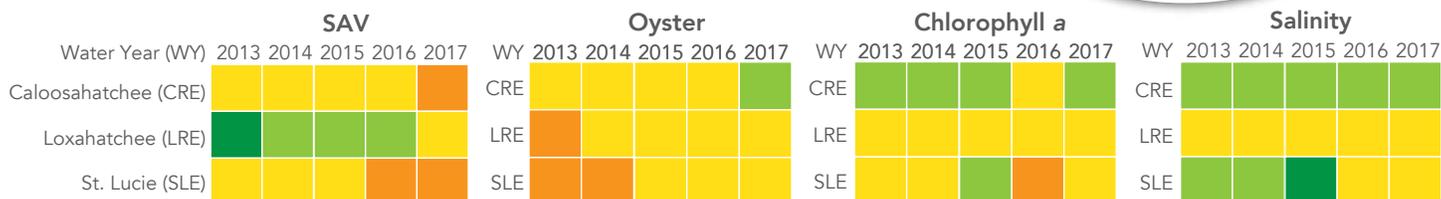
In general, the Northern Estuaries (Caloosahatchee River Estuary, Loxahatchee River Estuary, and St. Lucie River Estuary) are in fair to good condition. Submerged aquatic vegetation (SAV) declined or remained stable at low densities in all regions. Oyster scores ranged from poor to good throughout the five years with mostly fair scores. A cycle of salinity perturbations negatively affected oysters, but when salinities were favorable the oysters rebounded. Benthic infauna were in good condition, while salinity and chlorophyll a were in good to fair condition. The Northern Estuaries are impacted by human control of flows that alter volume, distribution, circulation, and temporal patterns of freshwater inflows, and natural events like hurricanes, El Niño, and drought. These cause sub-optimal salinities that have negative impacts on SAV, oysters, and benthic infauna.

Select indicator scores by year from Water Years 2013–2017.

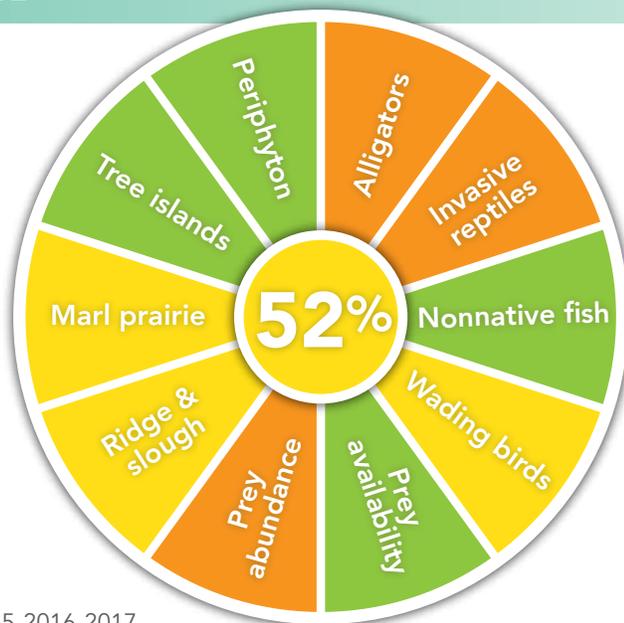
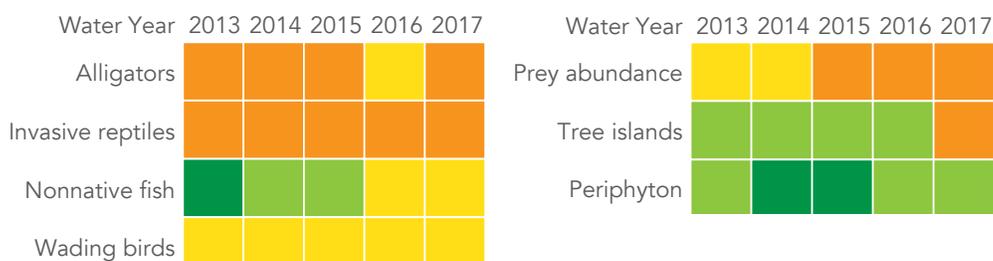
In the Greater Everglades region, conditions varied throughout the five-year reporting period with indicator scores ranging from good to poor. Conditions for periphyton were good despite a shift in periphyton community structure. Tree islands were also in the good range due to resilience of the islands in conservation areas. Although nonnative fish had a good score overall, the score ranged from good to fair with more nonnatives in recent years. Invasive reptiles also continued to increase in number and expand their range, scoring poor overall. Multiple years of wet conditions impacted prey availability, and as a result, most wading bird targets were not met. Prey abundance and alligator indicators were impaired. Marl prairie and ridge and slough habitat were degraded; however some areas of marl prairie habitat have shown improvement.

Select indicator scores by year from Water Years 2013–2017.

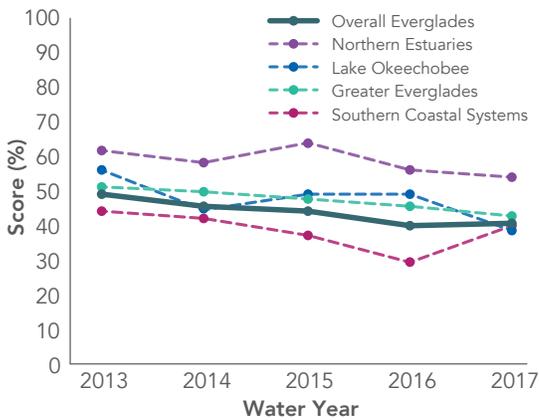
Everglades overall and region scores from Water Years 2013–2017 (May 1, 2012–April 30, 2017).

An overall score of 45%, fair, for the Florida Everglades is concerning. This means that the ecosystems of the Everglades are struggling to support the plants and animals that live there and the natural services they provide to people. Without healthy ecosystems, the economy, tourism, and recreational activities of south Florida suffer. However, there are many restoration projects scheduled for the next ten years that will help improve these conditions.

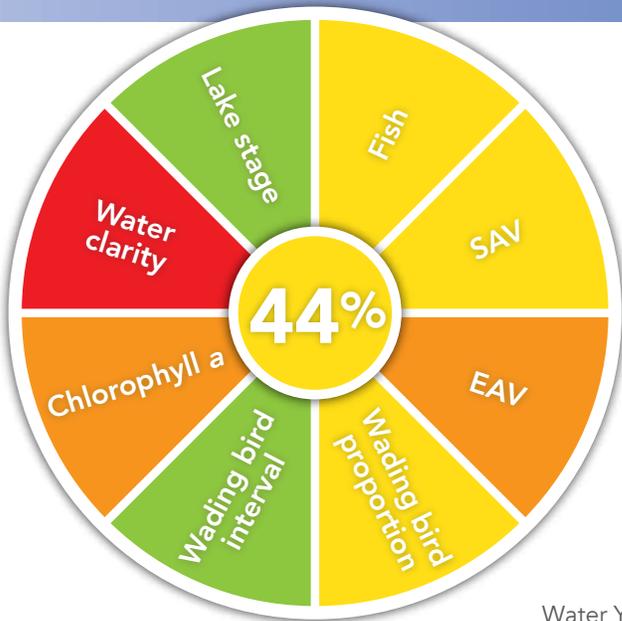
Indicators evaluated in Lake Okeechobee were fish, submerged aquatic vegetation (SAV), emergent aquatic vegetation (EAV), wading bird proportion (based on prey density), wading bird interval between exceptional nesting years, chlorophyll a, water clarity, and lake stage. Lake stages were close to desired targets, except for several high-water events during the peak of the summer growing season. These untimely exceedances may explain the difference between lake stage scores and those for flora and fauna. EAV and SAV were poor to fair, likely affecting fish and wading bird indicators; though the wading bird interval indicator scored well. Water clarity scores were very poor and chlorophyll a scores were poor, likely affecting SAV and fish indicators.

Water Year	2013	2014	2015	2016	2017	Water Year	2013	2014	2015	2016	2017
Fish	Green	Yellow	Green	Green	Yellow	Chlorophyll a	Green	Red	Red	Green	Red
SAV	Green	Orange	Orange	Orange	Orange	Water clarity	Yellow	Red	Red	Red	Red
Wading bird proportion	Orange	Yellow	Yellow	Yellow	Orange	Lake stage	Green	Yellow	Green	Green	Orange

Select indicator scores by year from Water Years 2013–2017.

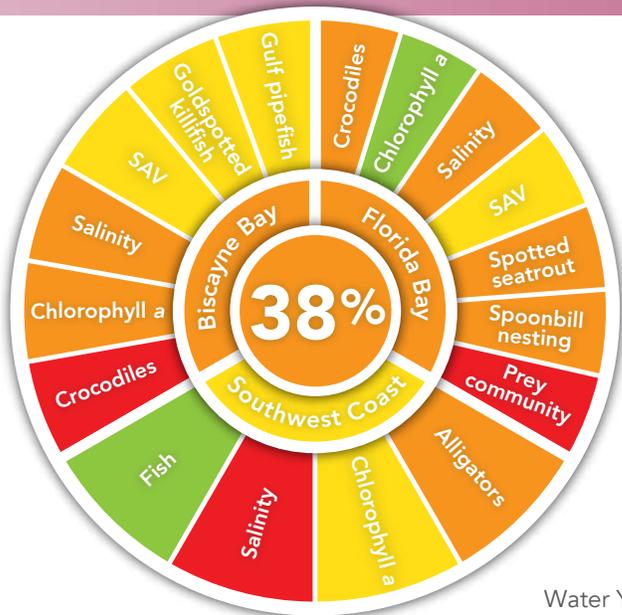
Overall, the Southern Coastal Systems regions (Biscayne Bay, Florida Bay, and the Southwest Coast) are in poor to fair condition. Reduced freshwater flow combined with sea level rise has resulted in increased salinity throughout the region. Elevated salinity, due to a local drought in 2014 and 2015, negatively impacted crocodiles, gulf pipefish, and submerged aquatic vegetation (SAV) in Biscayne Bay and Florida Bay. Spoonbill nesting, prey community, and spotted seatrout are in poor to very poor condition. Gold spotted killifish, gulf pipefish, and fish in the Southwest Coast region were in fair to good condition. To improve the ecological processes and overall health of the Southern Coastal Systems region, restoration of freshwater flow will need to continue in the years to come.

Biscayne Bay						Florida Bay					
Water Year	2013	2014	2015	2016	2017	Water Year	2013	2014	2015	2016	2017
Crocodiles	Red	Red	Red	Red	Orange	Crocodiles	Yellow	Yellow	Yellow	Orange	Orange
Salinity	Orange	Orange	Red	Orange	Orange	Salinity	Yellow	Yellow	Red	Orange	Orange
SAV	Yellow	Yellow	Orange	Yellow	Yellow	SAV	Green	Green	Green	Yellow	Yellow
Gulf Pipefish	Yellow	Green	Yellow	Yellow	Yellow	Spoonbill Nesting	Yellow	Orange	Orange	Orange	Orange

Select indicator scores in Biscayne Bay and Florida Bay by year from Water Years 2013–2017.

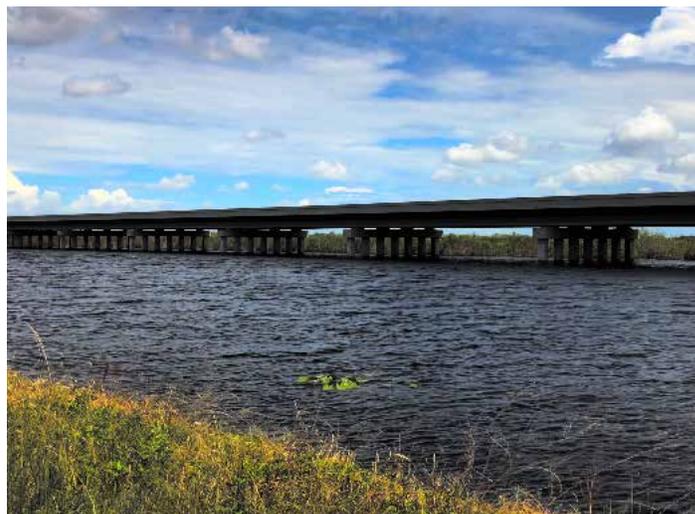
Water flowing under Tamiami Trail bridge. Photo by Susan Bennett.

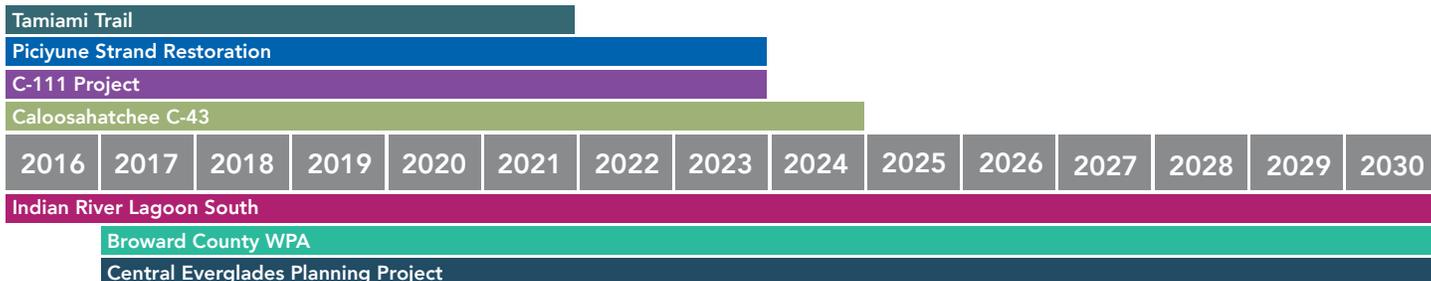
Timeline of important projects in Everglades restoration.

Over the past five years, the Comprehensive Everglades Restoration Plan (CERP) has made progress in several restoration projects. Some projects implemented under the CERP are:

Progress is expected to continue as more projects are planned and implemented. During the next five years, the Central Everglades Planning Project will make significant progress towards increasing water storage, improving water quality, and removing canals and levees to restore natural flow patterns. Planning
